ANNUAL REPORT FOR 2009

Roanoke River Overflow Mitigation Site Northampton County TIP No. B-1303

Prepared By:
Natural Environment Unit & Roadside Environmental Unit
North Carolina Department of Transportation
July 2009

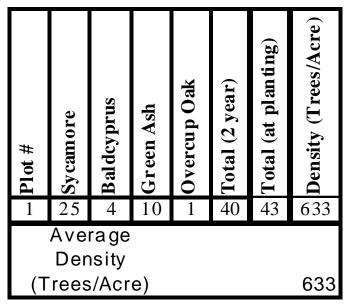
2.3 Results of Vegetation Monitoring

Site Notes: The restoration area is re-attaining wetland jurisdictional status and the planted species are surviving. Site had pockets of standing water at the time of monitoring. Other species noted: *Juncus* sp., black willow, red bud, fennel, cattail, smartweed, briars, red maple, *Pluchea* sp., sedge, pokeberry, ragweed, lespedeza, stinkweed, mimosa, and other various wetland species.

There was one vegetation monitoring plot established throughout the 0.75 acre site. The 2009 vegetation monitoring of the site revealed an average density of 633 trees per acre. This average is well above the minimum success criteria of 320 trees per acre for year one.
